**Flood Control Project Maintenance  
Levee Inspections**

**Fall 2013 Levee Maintenance Deficiency Summary Report**

**Sutter Maintenance Yard Maintenance Area 0007**

Waterway			Bank	Unit Miles
Unit No. 01 Feather River			Right	12.07
	Spring (March - May)	Summer (June - August)	(September - November) Fall	Winter (December - February)
Unit Maintenance Rating (Fall Only)			<b>A</b>	
Date of Inspection	04/08/2013 - 04/08/2013		10/21/2013 - 10/21/2013	
DWR Inspector	Rick Burnett		Matthew Hoffman	
Accompanied By	Jason Cooper Sutter Maintenance Yard		Jason Cooper Sutter Maintenance Yard

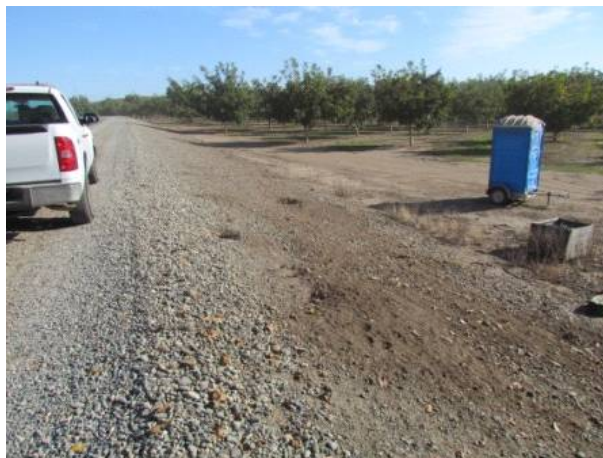
mhoffman\_f\_20131028\_675.JPG

This photo was taken from the crown of the levee facing north looking down the slope at rodent holes. Fall 2013.

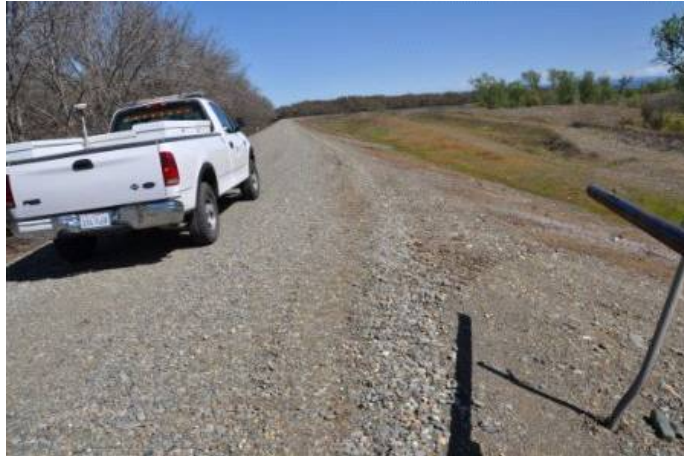
mhoffman\_f\_20130917\_019.JPG

W/S slope has been repaired.

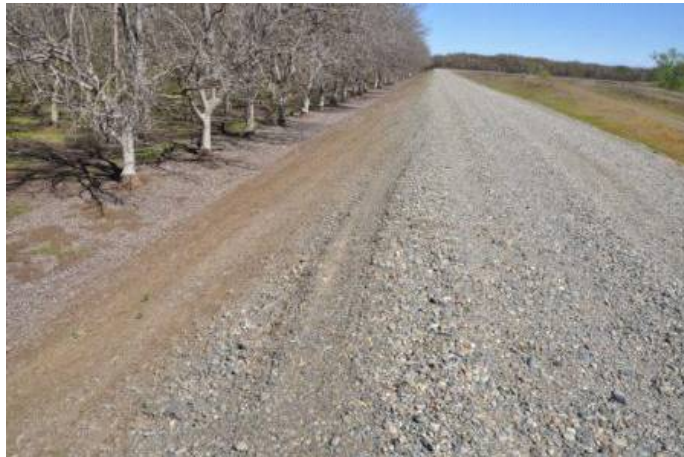
mhoffman\_f\_20130917\_018.JPG

L/S slope has been repaired.

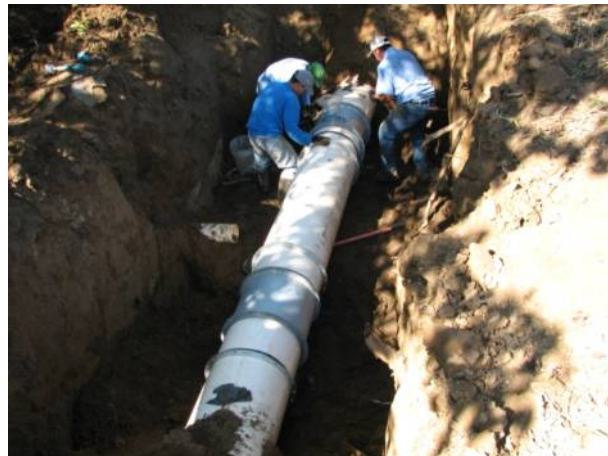
mhoffman\_f\_20130917\_029.jpg

Levee Mile Report Line	83
Start Levee Mile	2.88
End Levee Mile	2.88
Location	Land Side
Category	Earthen Levee
Item	Encroachments

This photo shows a pipe approximately 24 inch in diameter at the landside toe of the levee, the pipe runs parallel with the levee, they are repairing the existing pipe.

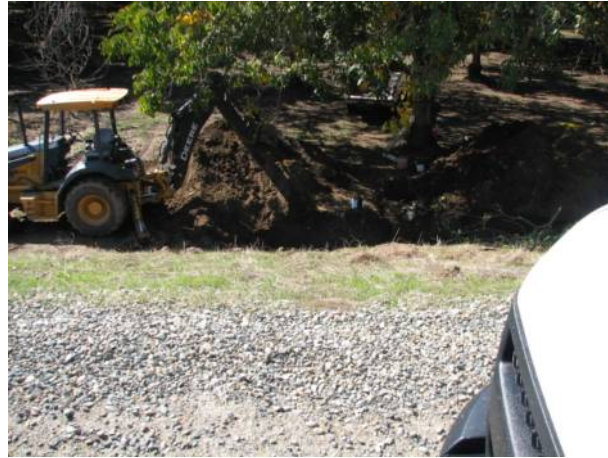
mhoffman\_f\_20130917\_030.jpg

This is looking from the crown of the levee at the pipe repair site. Status of a permit is unknown and no verification of the repair was available.

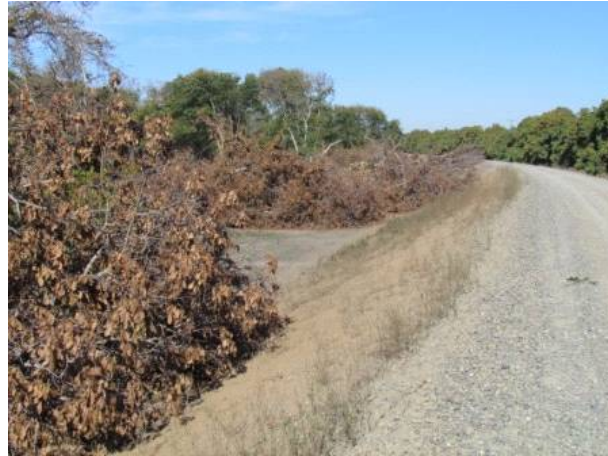
mhoffman\_f\_20131028\_679.JPG

This photo was taken from the levee crown facing north looking at walnut trees stacked on the landward slope. Fall 2013.

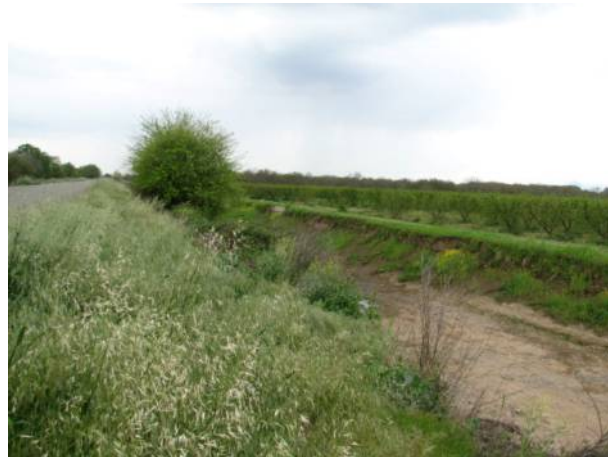
mhoffman\_f\_20130917\_024.jpg

Levee Mile Report Line	98
Start Levee Mile	3.85
End Levee Mile	5.37
Location	Land Side
Category	Earthen Levee
Item	Encroachments

Levee mile 5.37. This is a photo of the Ag ditch on the landside slope and toe.

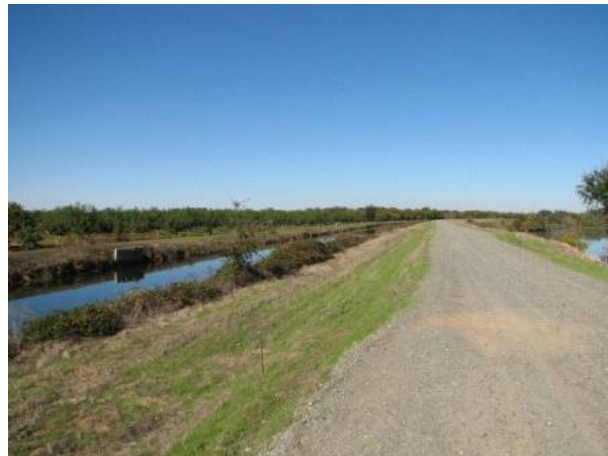
mhoffman\_f\_20130917\_025.jpg

Levee Mile Report Line	98
Start Levee Mile	3.85
End Levee Mile	5.37
Location	Land Side
Category	Earthen Levee
Item	Encroachments

Ag ditch landside slope and toe.

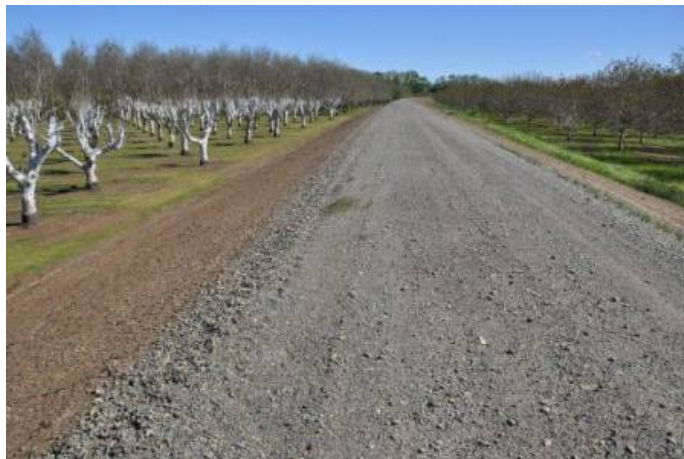
mhoffman\_f\_20130917\_013.JPG

Levee Mile Report Line	114
Start Levee Mile	5.38
End Levee Mile	5.98
Location	Water Side
Category	Earthen Levee
Item	Encroachments

This photo shows the stockpile has been removed.

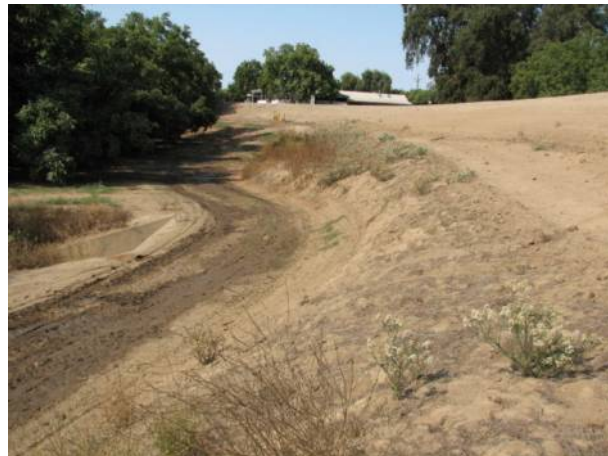
mhoffman\_f\_20130917\_012.JPG

Levee Mile Report Line	114
Start Levee Mile	5.38
End Levee Mile	5.98
Location	Water Side
Category	Earthen Levee
Item	Encroachments

This photo shows vehicle traffic has cut into the toe of the levee.

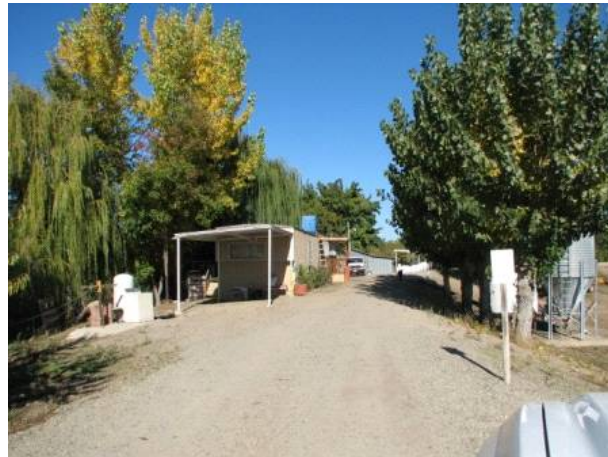
mhoffman\_f\_20130917\_022.jpg

Levee Mile Report Line	122
Start Levee Mile	5.42
End Levee Mile	5.42
Location	Land Side
Category	Earthen Levee
Item	Encroachments

Levee mile 5.42. This photo shows a building on the landside crown, shoulder and slope.

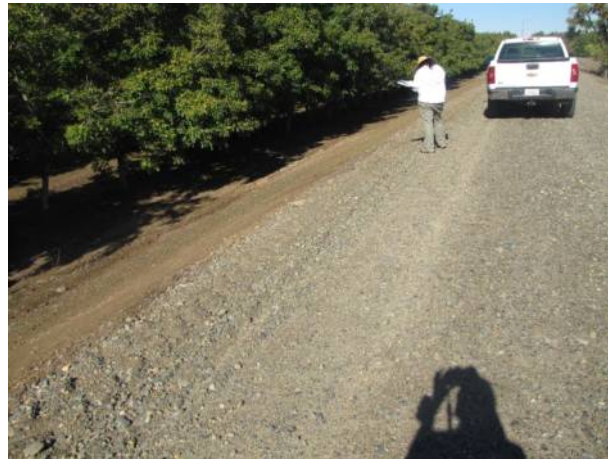
UCIP\_6894.jpg

View of landward side and levee crown looking upstream at crossing. Staff is standing adjacent to cavity located on landward shoulder.

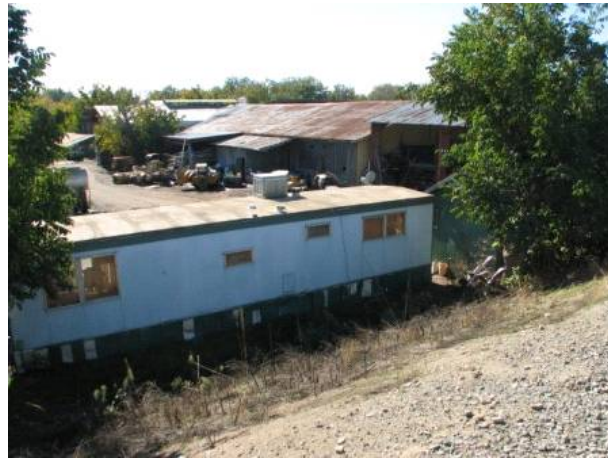
mhoffman\_f\_20130917\_028.jpg

Levee mile 9.79. This photo shows a building at the landside toe.

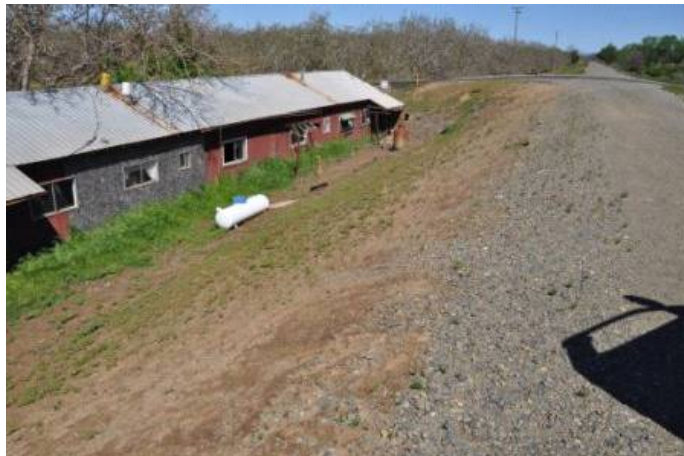
mhoffman\_f\_20130917\_021.JPG

Levee Mile Report Line	199
Start Levee Mile	11.24
End Levee Mile	11.24
Location	Land Side
Category	Earthen Levee
Item	Encroachments

L/S levee toe- Abandoned building.

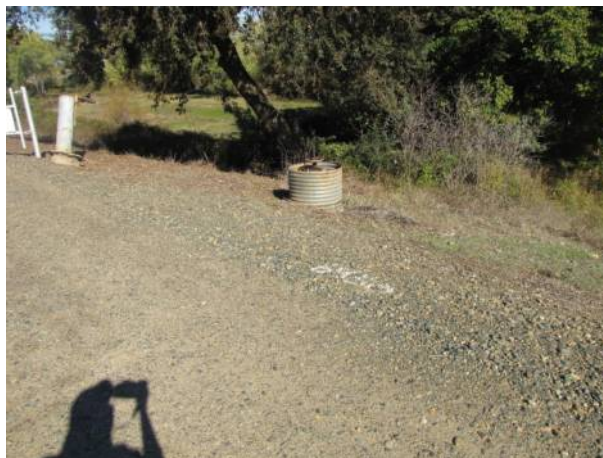
UCIP\_3603.jpg

View of waterward side looking upstream at crossing.

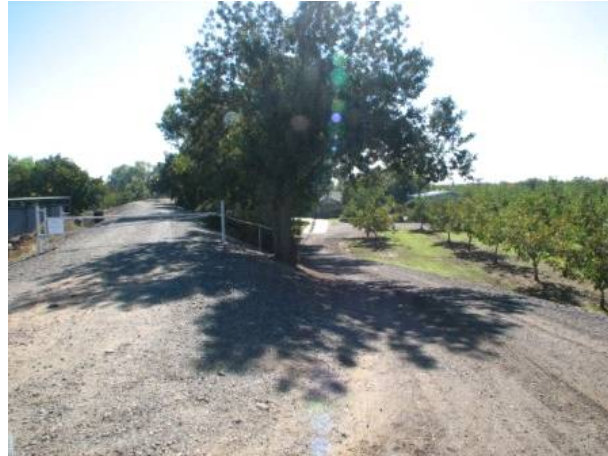
mhoffman\_f\_20130917\_027.jpg

Landside landscaping levee mile 11.63.
